An Investigation of Double Collisions of Pickup Trucks with Multiple Fatalities in Narathiwat Province, Thailand, October 2023

Tamonwan Chatngoen^{1*}, Piyaporn Saeai², Nutjanat Choosri², Trakarnkoon Chattrawongwiwat², Choopong Sangsawang², Farooq Phiriyasart^{2,3}, Chuleeporn Jiraphongsa⁴

Abstract

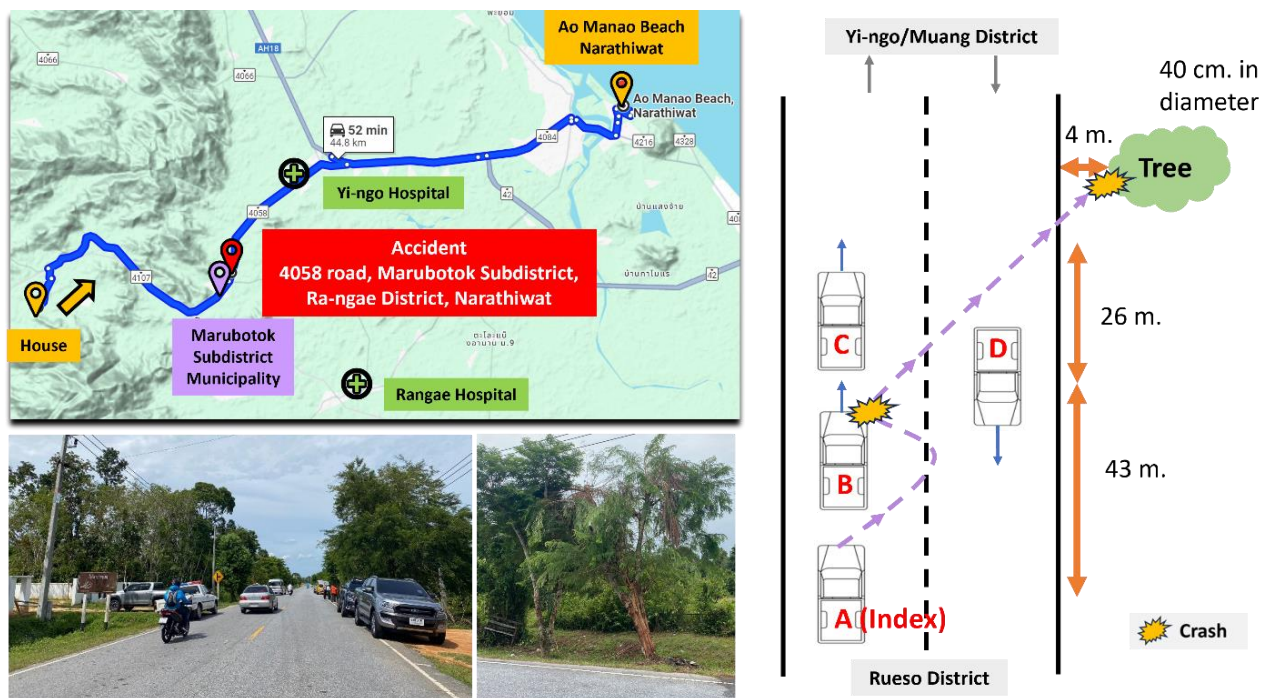
The accident occurred on a section of the 4058 Road (between the 3rd and 4th-kilometer mark) in Marubotok Subdistrict, Ra-ngae District, Narathiwat Province. It was a straight 2-lane highway, asphaltic concrete, flat road with a smooth surface and clear road line. There was no speed limit sign, and trees were located along the roadside (Figure 1). Close to the accident site were Marubotok Subdistrict Municipality and two district hospitals: Yi-ngo Hospital, the nearest hospital—about 6 kilometers away, and Rangae Hospital—about 12 kilometers away. Narathiwat Hospital (24 kilometers away), the provincial hospital, was associated with the Emergency Medical Services Command and Control Center of Emergency Medical Services section.

On 11 Oct 2023, at 12:15 PM the index vehicle (Vehicle A), carrying 11 people including the driver, departed from a house in Rueso District, Narathiwat Province, heading to Mueang District, Narathiwat Province (Figure 1). At 12:48 PM pickup truck A hit another pickup truck (Vehicle B), carrying six passengers including the driver, while trying to overtake it and another vehicle (Vehicle C) on the right. A car (Vehicle D) was moving in the opposite lane. However, the PSD was insufficient causing Vehicle A to quickly swerve back into its lane, resulting in a collision between its wheel and those of Vehicle B.

After the collision, the wheel rims of both vehicles were fractured. The Vehicle A experienced tire deflation, lost control and crashed into a 40-centimeter-in-

diameter roadside tree located four meters from the road. On the day the accident occurred, the sky was clear with no rain and good visibility.

Figure 1. A road map from departure to destination, accident location, and collision diagram of the accident, Narathiwat Province, 11 Oct 2023

The relevant authorities attended a meeting to assess risks and provide recommendations. We proposed and agreed on environmental and roadside management including adding speed limit signs along one kilometer of this road and felling roadside trees.

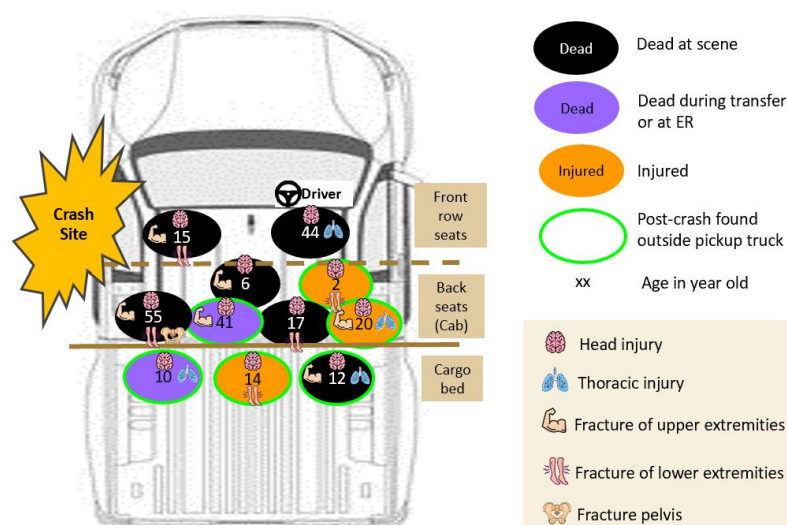
The passenger seat map and characteristics of body injured are shown in Figure 2. Six passengers were sitting in the cab, three in a cargo bed. The driver and another passenger were seated in the front. Among people who sat in the cab, 67% died (4/6) which was the same percentage as in the cargo bed (2/3). After the crash, six people were found outside the pickup truck and 50% of them died.

Figure 2. The passenger seat map in the index vehicle (Vehicle A) and characteristics of body injured in the accident, Narathiwat Province, 11 Oct 2023

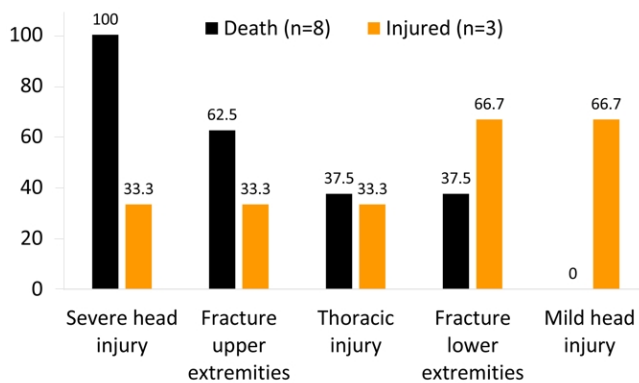
Among all 11 injured, severe head injury is the highest region of injury accounting for 81.8% followed by fractures upper and lower extremities at 54.5% and 45.5%, respectively. All eight dead had severe head injuries (100%), compared to one injured case (33.3%) (Figure 3).

Figure 3. Percentage of cases by body region of injury among deaths (n=8) and injured cases (n=3) of the accident, Narathiwat Province, 11 Oct 2023

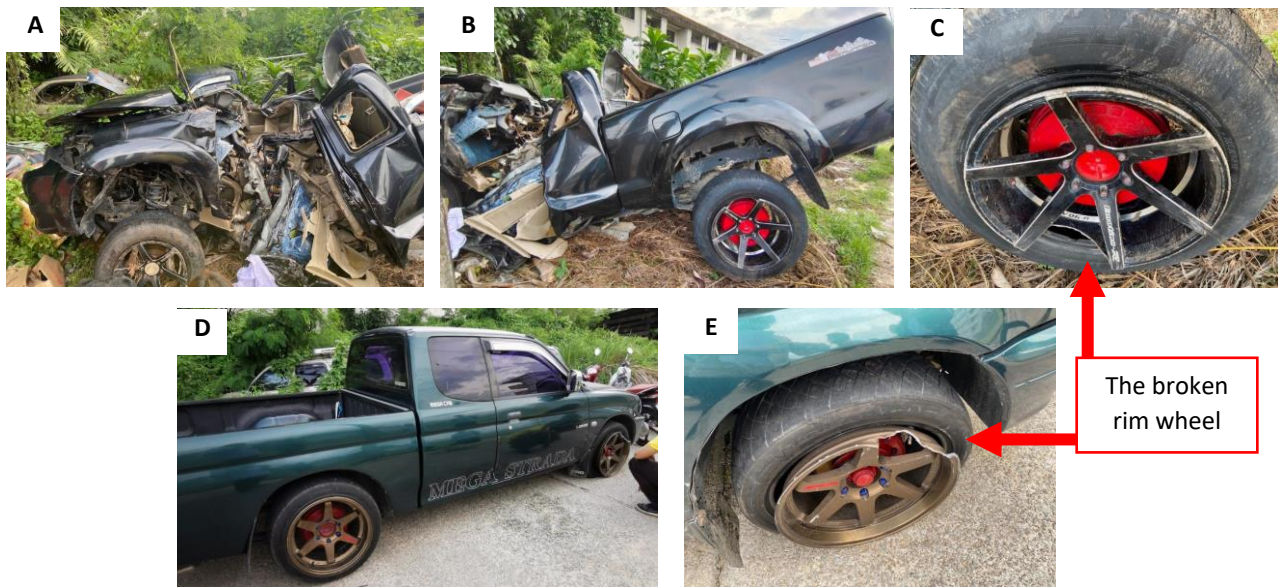
Vehicle A was a Toyota Hilux Vigo Champ. The tires were produced in 2018 and the treads were worn. Vehicle B was a Mitsubishi L200 Strada with customized wheels and tires protruding beyond the fenders (Table 1).

The crash speed was assumed to be 100 km/hr according to the AASHTO design guideline.¹¹ The roof and passenger area of Vehicle A collapsed with severe damage to the passenger cabin. The left front and left back rim wheels were broken. The right front rim wheel of Vehicle B was also broken (Figure 4).

Figure 4. The index's vehicle (Vehicle A) (A–C) and other party's vehicle (Vehicle B) (D–E) of the accident, Narathiwat Province, 11 Oct 2023

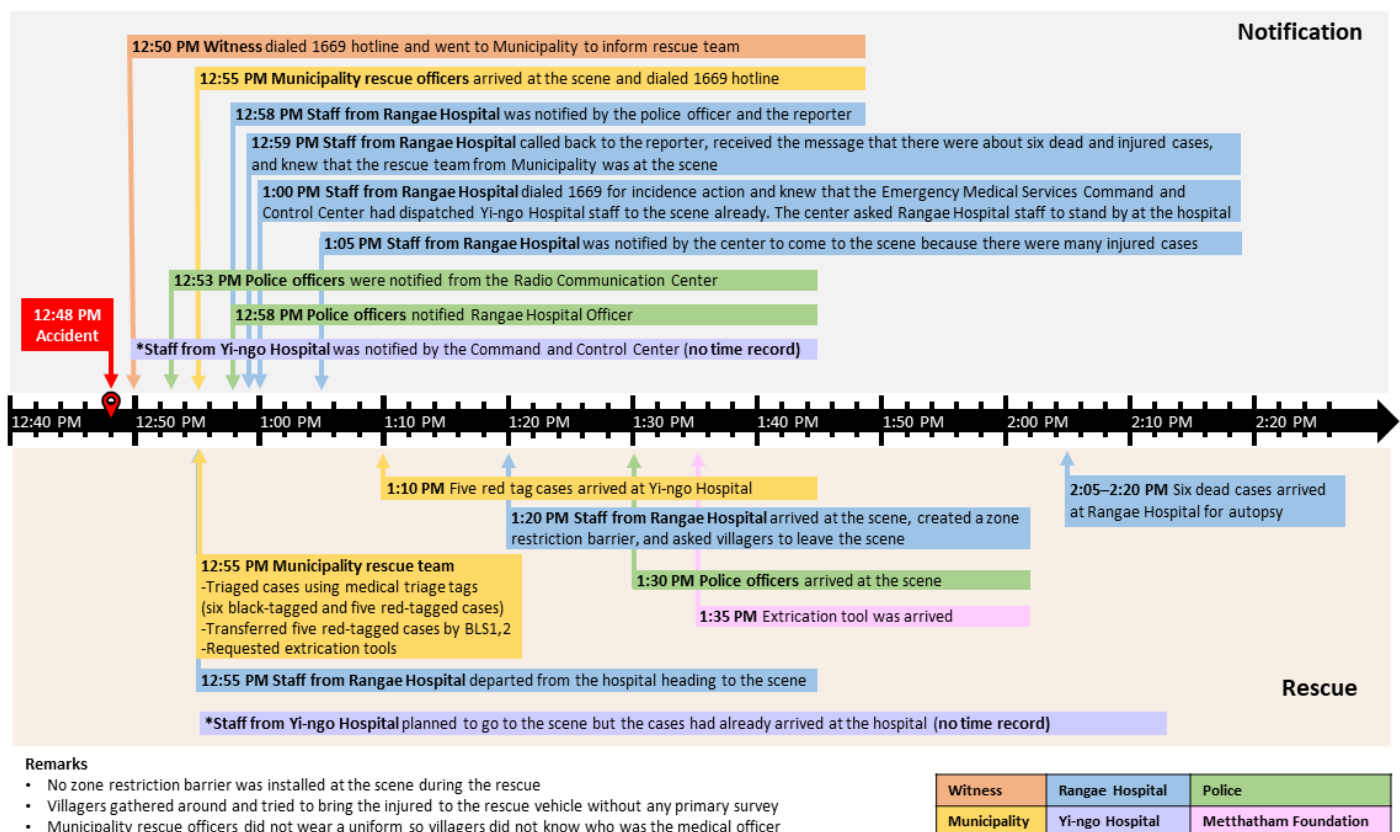
After the accident, staff from Yi-ngo Hospital were notified by the Center and planned to go to the scene but the Municipality rescue team arrived at the scene first and transferred 5 red-tagged cases to Yi-ngo Hospital already (Figure 5). Staff from Rangae Hospital received the message from the center to stand by at the hospital because the center had already dispatched staff from Yi-ngo Hospital to the scene.

Rangae Hospital staff were then notified to come to the scene and found only six black-tagged cases. The extrication tools arrived approximately 45 minutes after the collision because there were no extrication tools in this district. They were provided by the Narathiwat Methatham Foundation in Mueang District located 30 kilometers away. After that, Rangae Hospital staff transferred six dead cases to Rangae Hospital.

Figure 5. Emergency medical service timeline by notification and rescue process of the accident, Narathiwat Province, 11 Oct 2023

For short-term goals, the Provincial Public Health Office and the Emergency Medical Services Command and Control Center should provide knowledge of first aid management to villagers, and practice for mass casualty incidents in the community.
