An Investigation of a Tour Bus's Side Collision with Roadside Trees on National Highway No. 41, Pa We Subdistrict, Chaiya District, Surat Thani Province, Thailand, 3–4 Jan 2025

Abstract

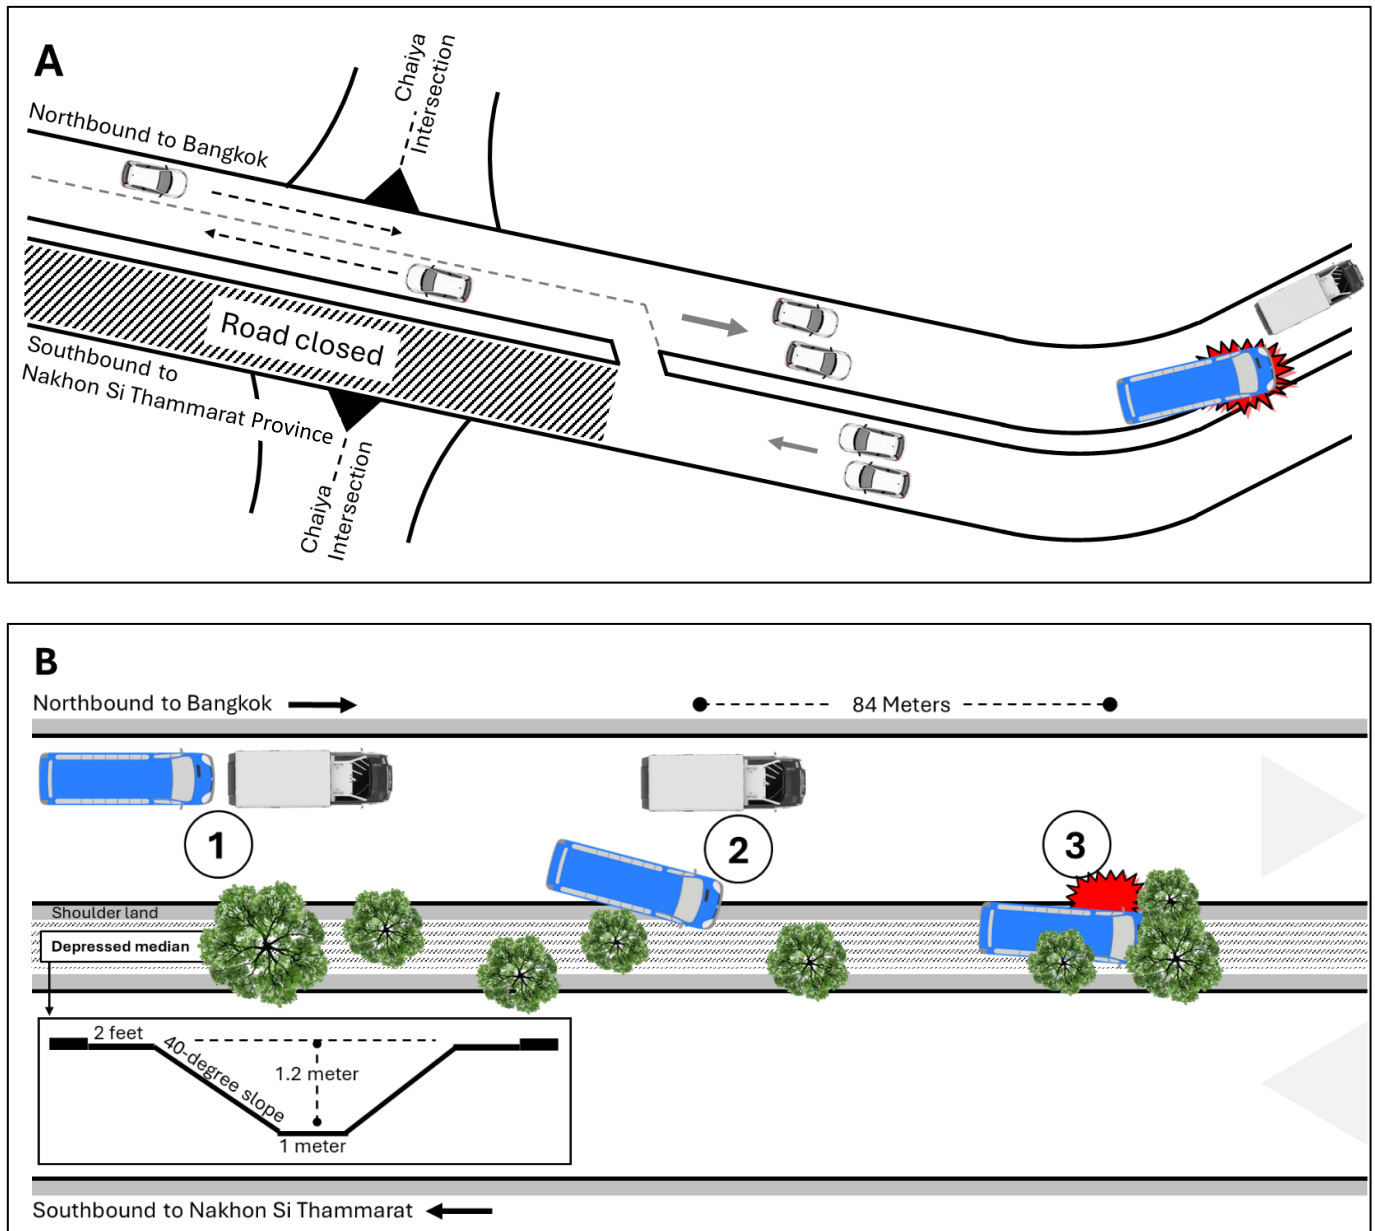
While the bus was overtaking the truck, the right front wheel of the bus moved onto the road's shoulder, which was 1–2 feet wide and covered with loose soil and grass. The driver, aware of the impending danger, accelerated the vehicle. An expert from the forensic police supported this supposition due to the existence of grass on the surface of the soil approximately 2–3 meters before the spot where the bus descended into the depressed median. After this distance, there was evidence of crushed grass made by tire marks of a vehicle travelling at high speed, suggesting that the speed of the bus during the collision was higher than 81 km/h. After the bus descended into the depressed median, which was sloped at an angle of approximately 40 degrees, it collided with three large trees (Figure 2).

The road was constructed of concrete and had been in use since June 2024. In this particular section of the road, there was a lack of lane markings, shoulder delineations, and street lighting. The incident occurred at night, during low visibility.

Figure 2. A diagram of National Highway No. 41 with a 2-kilometer stretch of road before the accident site (A) and pictorial of events (B) of a tour bus before (1) and during (2) overtaking a truck, and after colliding with trees (3), Surat Thani Province, 1 Jan 2025

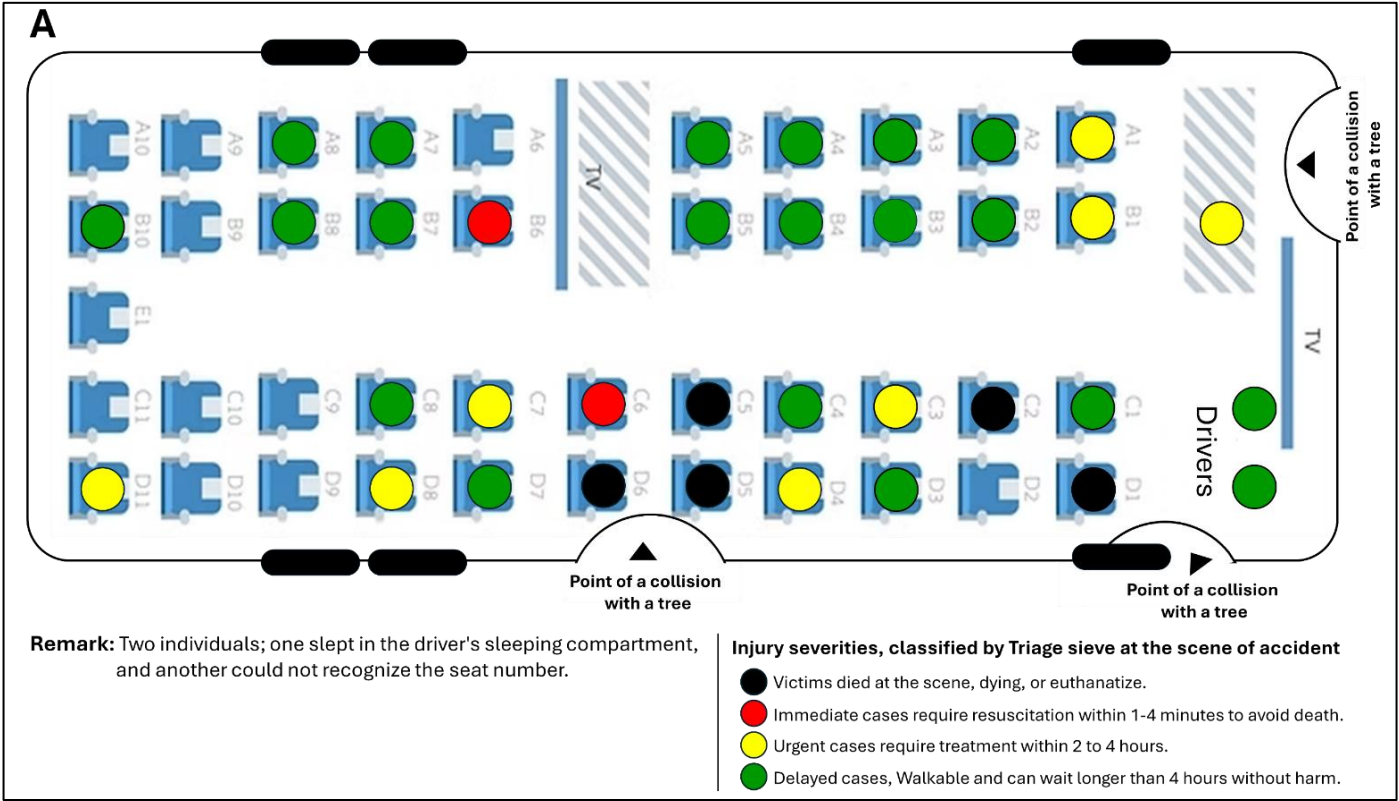
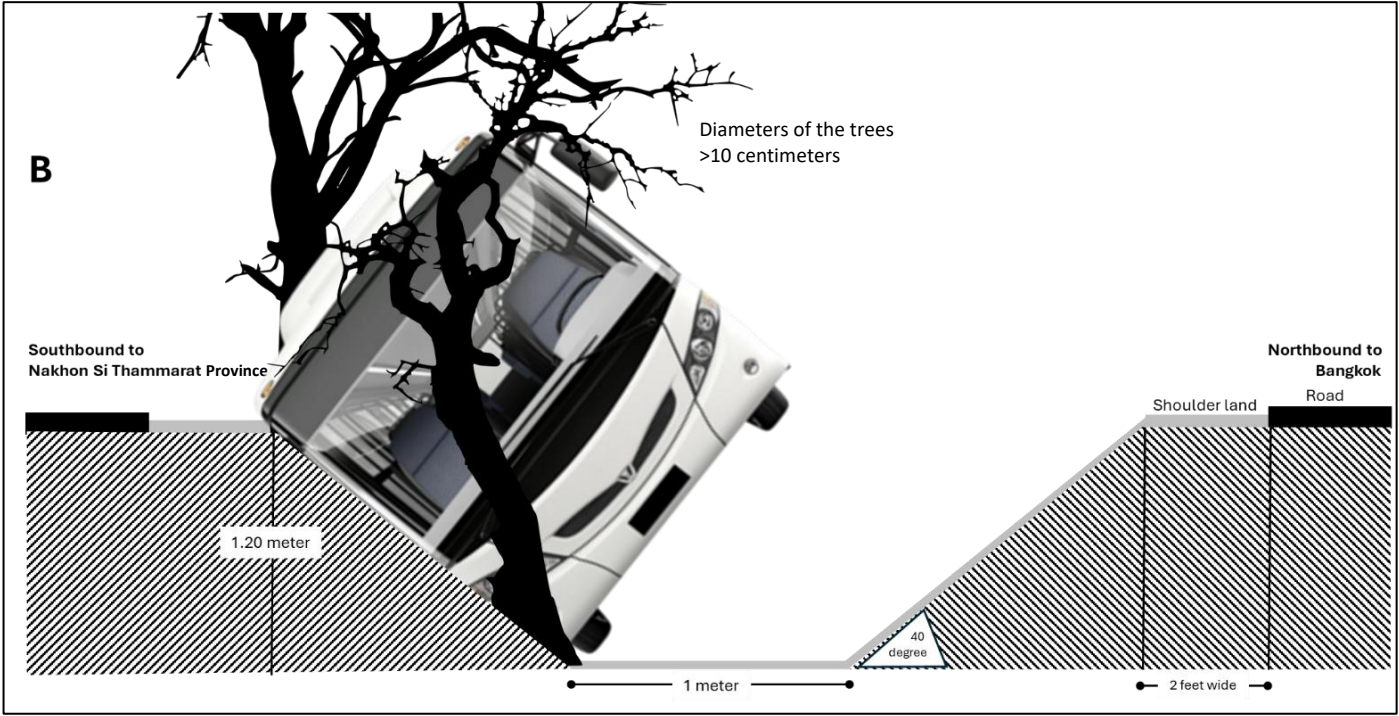
Figure 4A illustrates the distribution of accident victims based on the location of their seats. Those who died at the scene sat closest to the points of collision with the trees. Victims who were triaged as immediate and urgent sat adjacent to those who died. After the

collision, the bus came to rest in the position shown in Figure 4B. None of the passengers had their seatbelts fastened. Consequently, passengers who sat on the left side of the bus were thrown to the right, resulting in more severe injuries for those seated on the right side.

Figure 4. Bus seat map showing the distribution of injury severities (A) and the bus's final position during the post-crash period in the depressed median (B), National Highway No. 41, Surat Thani Province, 1 Jan 2025
