Drunk Driving, Sleep Deprivation, Unsafe Vehicle, and Poor Road Design: Converging Hazards in a Road Traffic Crash in Sukhothai Province, Thailand, 2025

Keywords: pickup truck, alcohol, microsleep, school truck, Thailand

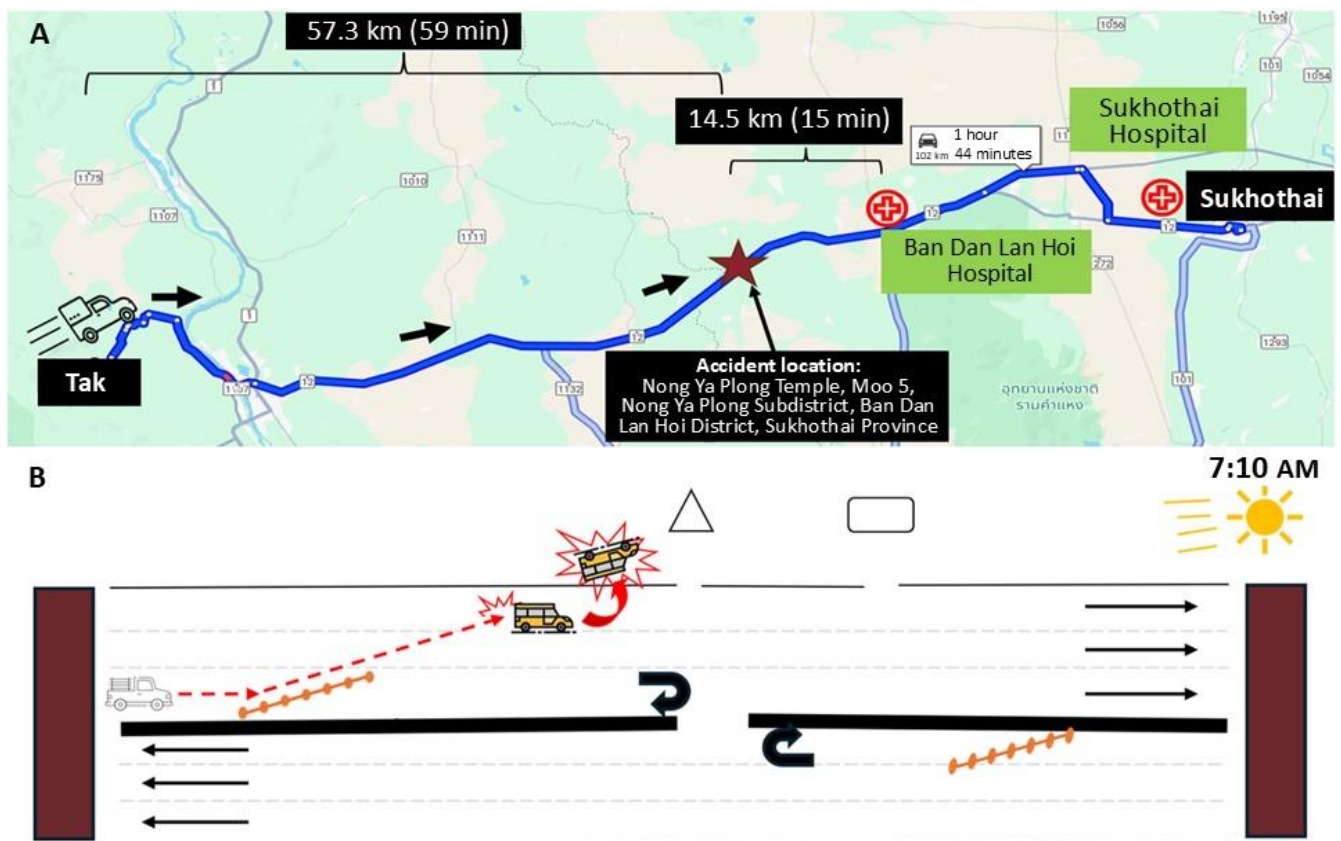
The collision diagram illustrated a northeast-bound passenger vehicle was traveling at approximately 50–70 km/h in the left-hand lane (Figure 1B). As the

speed of 100–120 km/h, made a sudden lane change to avoid traffic poles and subsequently made a rear-end collision with the passenger vehicle. The passenger vehicle then overturned and rolled into a roadside ditch.

Figure 1. (A) Map showing the pickup truck's route from departure (Tak Province) to destination (Sukhothai Province), the accident location, and the nearest hospital for the road traffic accident in Sukhothai Province on 10 Feb 2025. (B) A collision diagram illustrating the pickup truck rear-ending the school transport vehicle. The red dashed arrow indicates the path of the pickup truck as it abruptly moved to the left lane to avoid traffic poles.

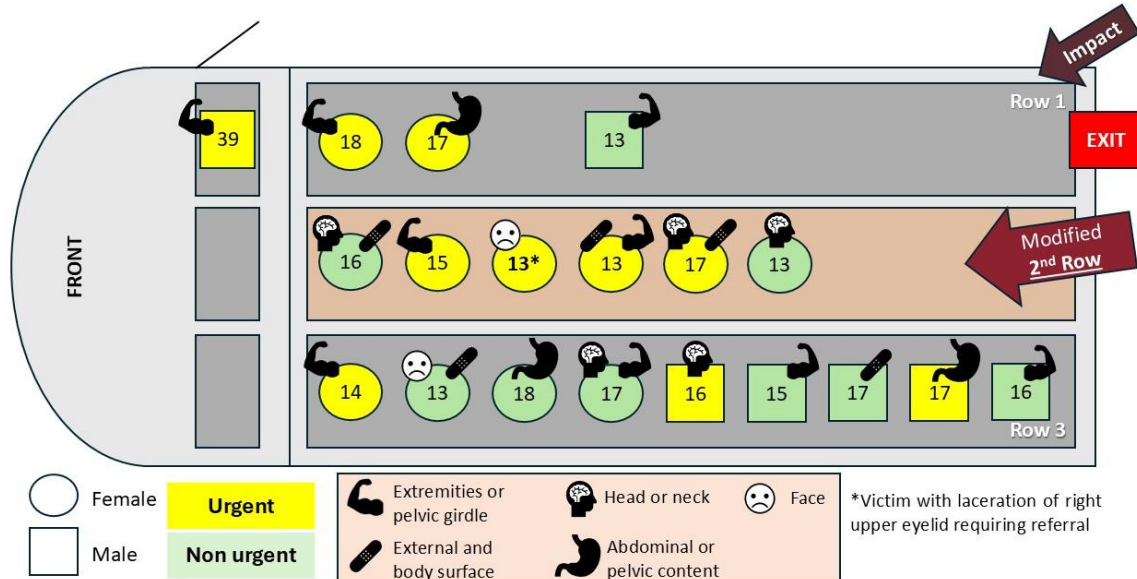
The passenger vehicle had been modified to include a third row of seats. This additional row lacked both seatbelts and handrails, features not permitted. The passenger who was admitted to hospital was seated in row 2, position 3 (Figure 2). The proportion of urgent cases was highest in rows 1 and 2 (67%; 2/3 and 4/6, respectively). The distribution of injury locations revealed the highest proportion of injuries to extremities (41%), followed by external body surface (26%), and head and neck (15%) (Supplementary Figure 1).

Figure 2. Seating arrangement in the passenger vehicle and corresponding injury characteristics of the road traffic accident in Sukhothai Province on 10 Feb 2025. The numbers within each shape denote the passenger's ages.

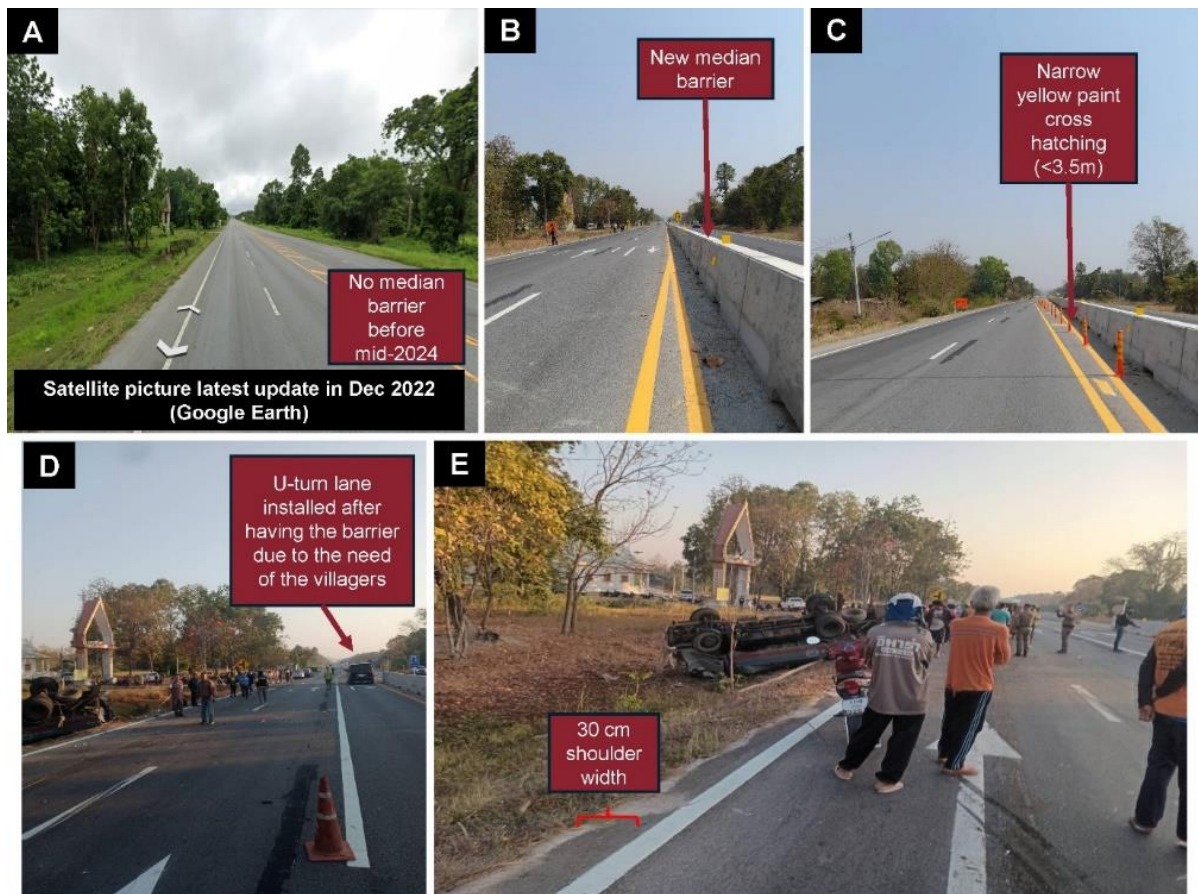
The road at the incident site is a straight, asphalt-paved four-lane highway with a recently constructed (June 2024) concrete barrier median installed to prevent cross-lane collisions (Figure 3). Approximately one month after construction, villagers requested that a U-turn be created near the entrance to the temple. During the incident, road conditions were dry with clear lane markings and no visual obstructions. The roadside included a dry ditch situated below road level. Visibility was adequate in the morning. The pickup

truck driver reported mild sun glare; however, it did not impair his visibility of other vehicles, traffic lane markers, or traffic poles. Warning signs and speed limit indicators were small and placed only after the U-turn, with none located within 100 meters before the U-turn. Specifically, four deviations from the GD-402 guideline specified by the Department of Highways, Thailand, for U-turns at a median barrier were identified: absence of a road shoulder, insufficient width (<3.5 meters) of yellow cross-hatchings, lack of post-U-turn cross-hatchings, and lack of pre-U-turn warning signs (Supplementary Figure 2).¹⁴

Figure 3. Images of the accident site on Jarod Withee Thong Road (Highway No. 12, Tak–Sukhothai route) between km 132+250 and km 133, in front of Nong Ya Plong Temple. (A) Google Earth image showing the previous road layout with no median barrier and only two lanes each way. (B) Photo taken on February 14, 2025, showing the newly constructed median barrier and approach containing orange traffic poles leading up to the U-turn bay, expanding the road to three lanes. (C) Image highlighting narrow yellow cross-hatching and unclear warning signs. (D, E) Photos taken on the day of the accident (10 Feb 2025) showing adequate visibility, visible tire marks from the passenger vehicle (upended), and a narrow road shoulder.

At the request of local villagers, a new median barrier was installed at the section of road near Nong Ya Plong Temple, followed by a lane reduction. However, the abrupt lane reduction and absence of adequate warning signs or speed limits posed a significant safety risk. Abrupt lane changes have been linked to increased crash risk, contributing to 33% of all road collisions in the U.S.^{26,27} Consistent with the present study, inadequate signage and speed control measures are well-documented environmental factors contributing to RTIs.²⁸

The steep roadside and narrow shoulder likely contributed to the increased risk and severity of the incident. Although most of the affected could walk unaided, the terrain posed challenges for rescuers during their extraction from the damaged vehicle. Narrow shoulders limit vehicle recovery space, reduce lateral clearance, and increase the risk of run-off-road crashes and abrupt maneuvers.^{29,30} Studies show that

As of 1 Apr 2025, the traffic in front of Nong Ya Plong Temple has been monitored. Two minor motorcycle accidents occurred, attributed solely to human factors. Recommended road changes—warning signs, speed limits, and median barrier closure—are under consideration by the Department of Highways and expected to be implemented in the next fiscal year.

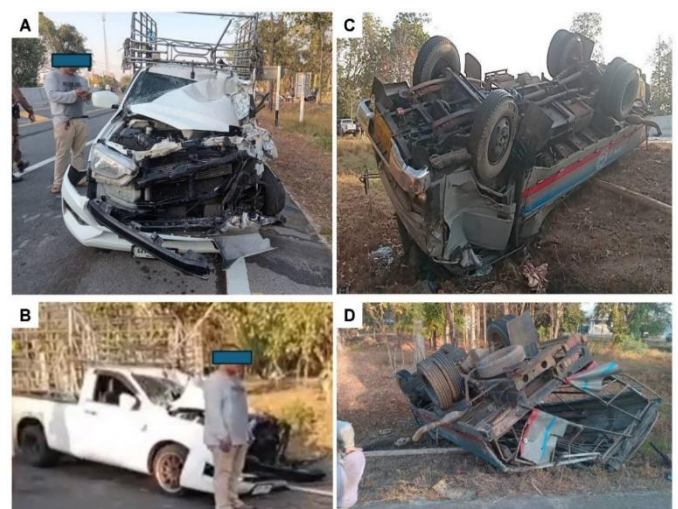
The pickup truck was a two-door truck with a modified metal cargo frame registered as a private passenger vehicle under the Motor Vehicle Act. It was covered by compulsory insurance through ERGO Insurance (18 Apr 2024–18 Apr 2025); no voluntary insurance was found with a recent inspection in April 2024. Post-crash inspection revealed front-end collapse on the passenger side, a detached grille, an open hood, and misaligned wheels, with greater damage on the passenger side (Figures 4A and 4B).

The modified passenger vehicle was a six-wheel vehicle registered for public transport use. It was covered by compulsory insurance from Viriyah Insurance (31 Dec 2024–31 Dec 2025), with no voluntary insurance. The vehicle featured reinforced steel framing, three rows of metal-framed bench seats fixed to the body, and no seat belts. Each row could accommodate approximately 10 passengers. The vehicle passed its most recent inspection in December 2024. However, the third row of seats had been removed prior to the inspection and was reinstalled afterward. Post-crash

damage included a collapsed roof on the driver's side, a crushed driver's door, and a detached seat from the metal frame (Figures 4C and 4D).

Figure 4. Post-crash images of the pickup truck and passenger vehicle. (A) Front view of the pickup truck; (B) side view of the pickup truck; (C) side view of the passenger vehicle; and (D) rear view of the passenger vehicle.

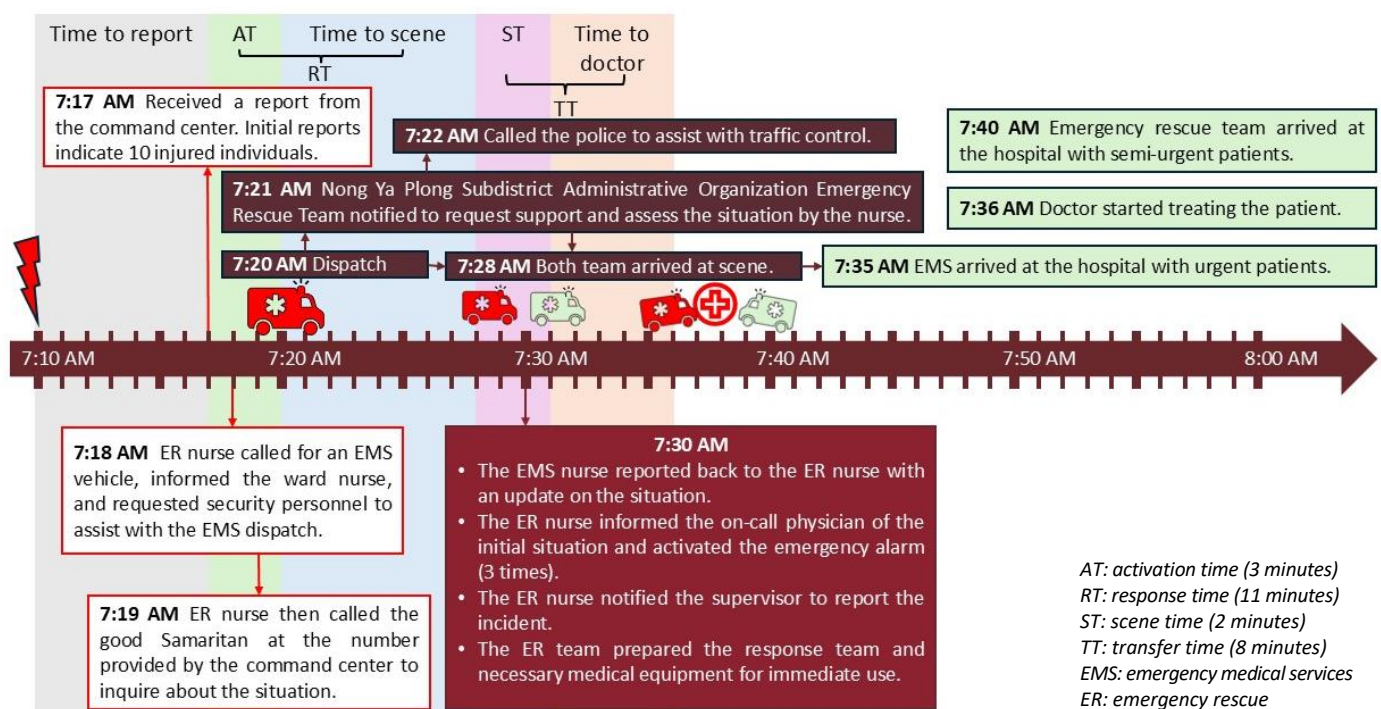
The incident occurred at approximately 7:10 AM and was reported to the police by a bystander. At 7:17 AM, the Emergency Room at Ban Dan Lan Hoi Hospital received notification from the EMS command center. An advanced life support vehicle was dispatched at 7:20 AM (activation time: 3 minutes). Concurrently, the EMS nurse requested support from the subdistrict administrative organization and coordinated traffic control with the police. Both EMS teams arrived at the scene by 7:28 AM. The first urgent case arrived at the hospital at 7:35 AM (Figure 5). Although the dispatch time was only one minute, an additional two minutes were required to collect complete incident details before deployment (Table 2).

Figure 5. Emergency medical services (EMS) timeline, including notification, rescue process, and time frame, based on the 2023 Provincial EMS Performance Scoring Index (PEPSI), for the road traffic accident in Sukhothai Province on 10 Feb 2025

Pre-hospital care at the accident site faced several challenges, including the absence of initial scene management due to the EMS team's lack of confidence and an unclear command structure. This led to no formal scene safety assessment or traffic control, despite a recent rescue training workshop in January 2025. Crowd control was limited by an insufficient number of authorities at the scene, the large size of the crowd, and the restless behavior of bystanders. Additionally, some victims' relatives moved injured individuals before the EMS arrived. The lack of designated triage zones hindered accurate casualty assessment. Pre-arranged support from the Nong Ya Plong Subdistrict Administrative Organization EMS enabled the timely transfer of patients to the hospital.
