Supplementary Figure 1. Proportion of the injured region of the passenger involved in the road traffic accident in Sukhothai Province on 11 Feb 2025. Each passenger may sustain more than one injured region.

Supplementary Figure 2. U-turn guideline for barrier median (GD-402) and gaps compared with the U-turn in front of Nong Ya Plong temple as investigated on 14 Feb 2024

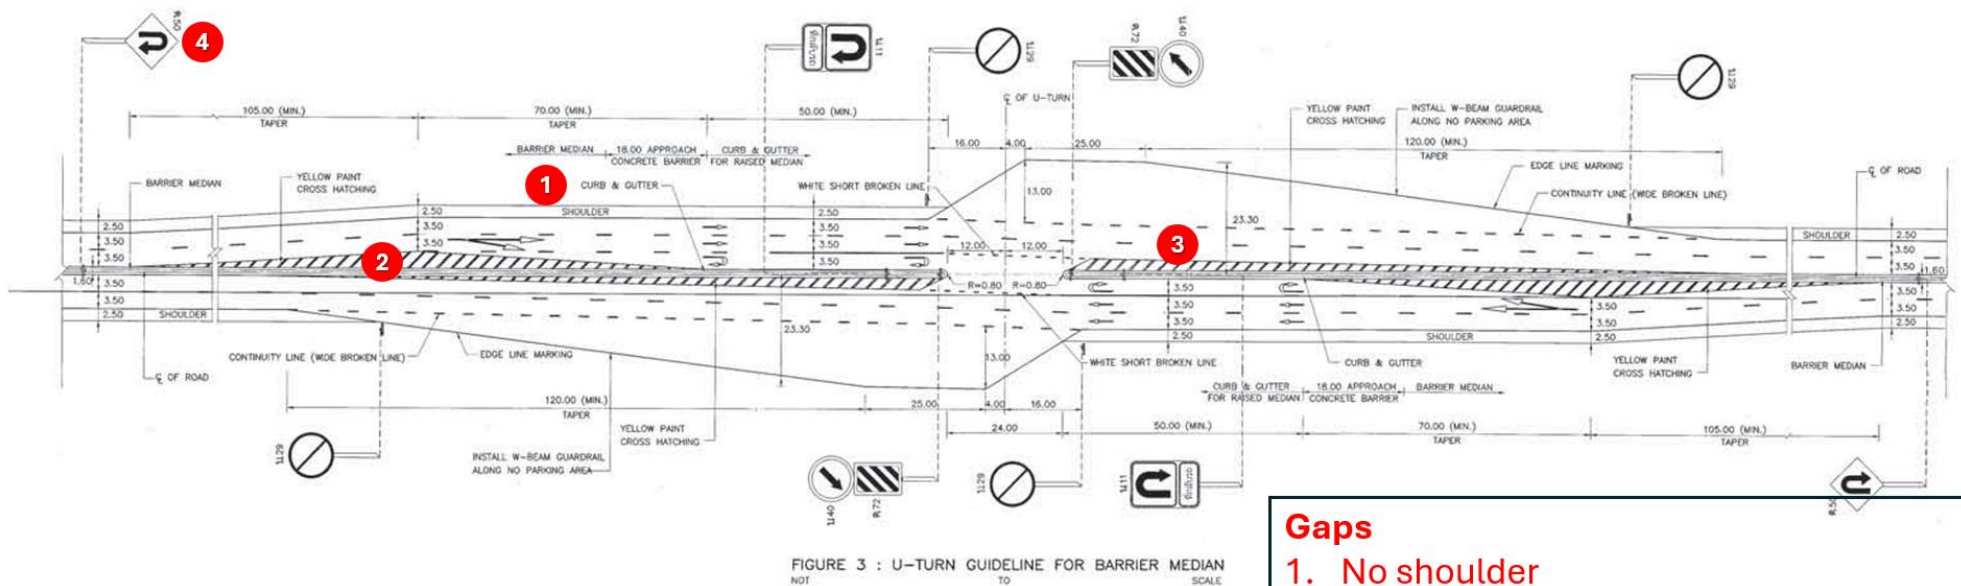
Gaps

1. No shoulder
2. Narrow yellow paint cross hatching (<3.5m)
3. No post U-turn yellow paint cross hatching
4. No initial pre-U-turn warning signs
