Topography alteration of different implant surfaces after an installation

Objective: The aims of present study were to investigate dental implant surface alterations after the installation.

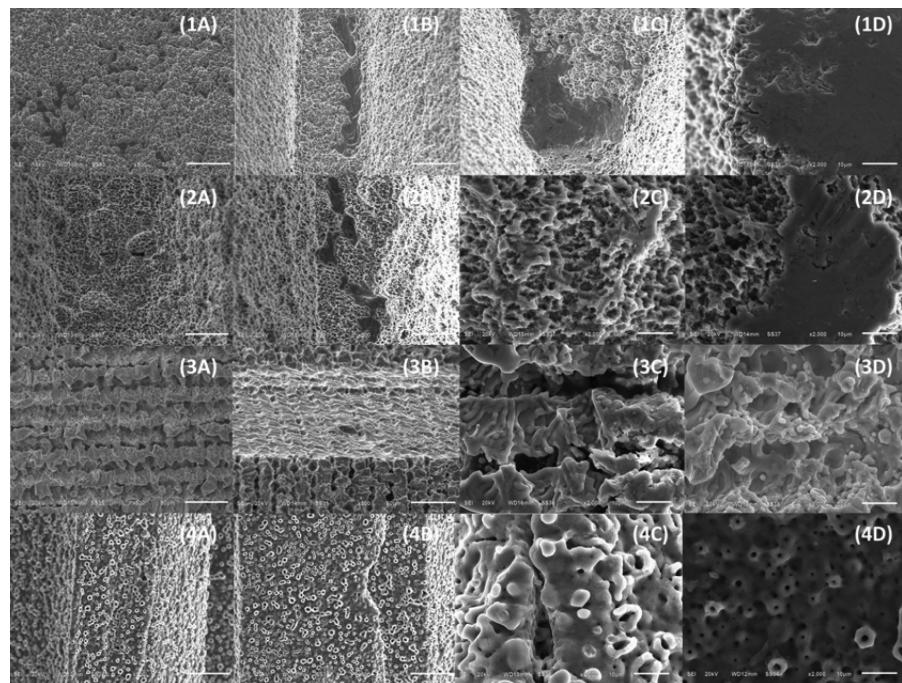
Figure 2 SEM images of all implants after installation into bone block

After installation, both SU and TS exhibited similar outcome. Top of the thread, especially coronal and apical part presented smoothening area varying from submicron to micron in size. The spike-like structure decreased sharpness. Some thread crests became blunter. Flank and valley areas rarely changed (Figure 2).

After installation, discontinuity of surface from chipping of titanium, depression and smooth area were found. Although the top of groovy unit was partially abraded, submicron roughness at the cliff and valley remained underneath the defect (Figure 2).

After installation, loss of typical volcano-like structure was identified randomly at thread top. Roughness decreased visually. Chipping and distortion at thread crests were found specifically at apical third of the implant in conjunction with crack line (Figure 2).

(1A) Decreased sharpness of SLA spike-like pattern.

(1B) Titanium plastic deformation.

(1C,D) Total loss of SLA surface structure.

(2A) Decreased sharpness of SLA spike-like pattern.

(2B) Titanium plastic deformation.

(2C) Partially loss of SLA surface structure.

(2D) Total loss of SLA surface structure.

(3A) Superficial abrasion of surface modification layer.

(3B) Depression on the surface.

(3C) Titanium plastic deformity.

(3D) After superficial abrasion, the roughness below still remained.

(4A) Smoothened surface, deformed thread crest, and crack line.

(4B) Chipping of titanium at thread crest.

(4C) Micro crack line and obstructed volcano nodule.

(4D) Partial loss of typical volcano-like structure.

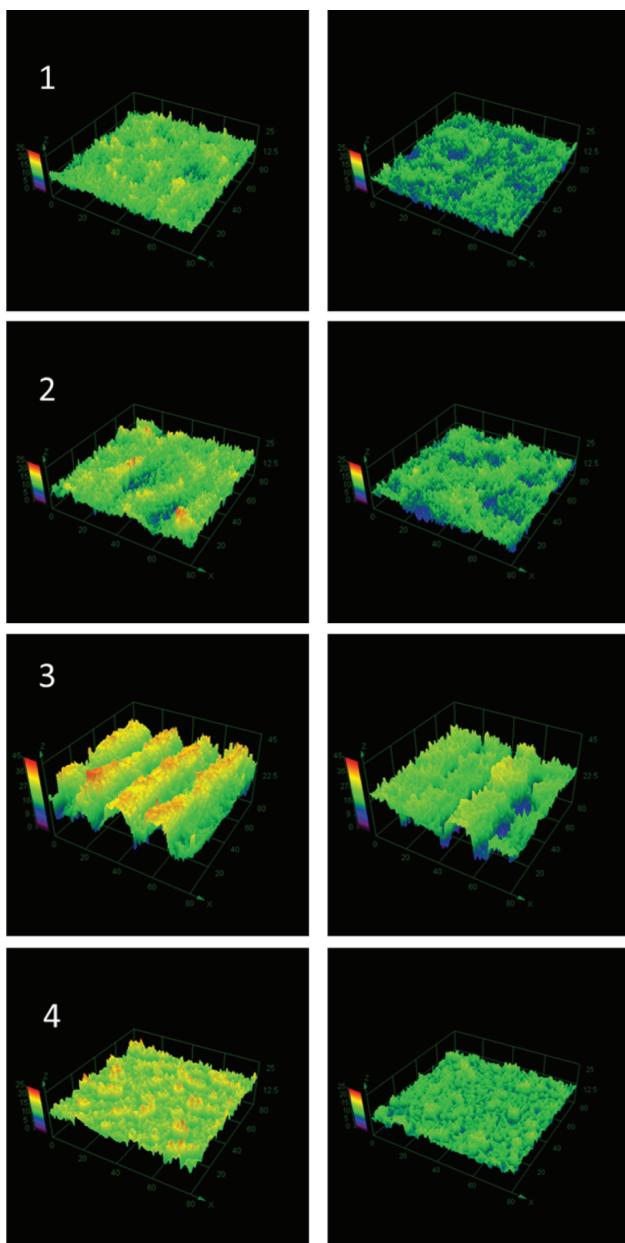
Figure 3 Comparison of topography before (left) and after installation (right) of 4 commercial implants; SU (1), TS (2), BP (3), and NO (4)

Overall, the surface alteration was not remarkable. The thread top and crest were the most affected area. Loss of typical surface modification structure was a major alteration.

The results are summarized in (Table 4). 3D topography images are shown in (Figure 3). BP possessed the highest Sa and S-ratio, while NO occupied the lowest Sa and S-ratio.

All implant groups experienced significant decreased Sa and S-ratio. The percentage decrease of S-ratio was generally 4.5-5.5% wherein SU presented the highest percentage decrease (5.5%) and NO presented the lowest percentage decrease (4.5%). Percentage decrease of Sa from BP, SU, TS, and NO was 15, 19, 5, and 2%, respectively. Sku in all groups remained the same. Ssk from SU significantly increased after insertion.
