The restoration of a tooth with fractured cusps and short clinical crown: A case report

Keywords: additional slot preparation, cuspal fracture, short clinical crown, tooth fracture

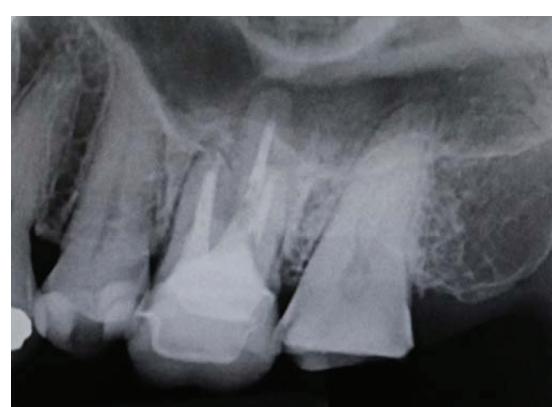
Figure 2 The radiograph showed normal apical tissue of the upper left second molar.

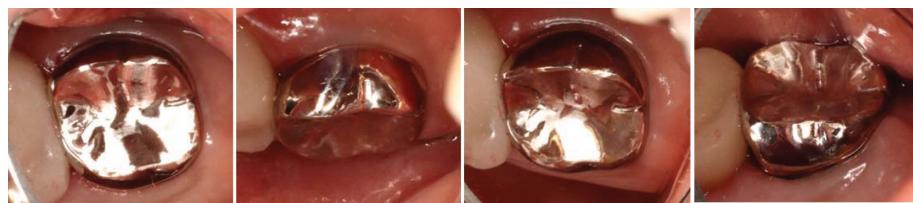
Figure 5 The tried-in restoration to the preparation for verification of adaptation, restoration contour and contact area to an adjacent tooth. Then, the occlusal surface was adjusted to make simultaneous occlusion.

For the next appointment, after provisional crown removal, the tooth was cleaned with moisten pumice and a rubber cup. The crown restoration was tried-in to the tooth. The adaptation was verified as well as the restoration contour and contact area to an adjacent tooth. After that, the occlusal surface was adjusted to make simultaneous occlusal contact, both in centric and eccentric movement, without interferences (Figure 5).

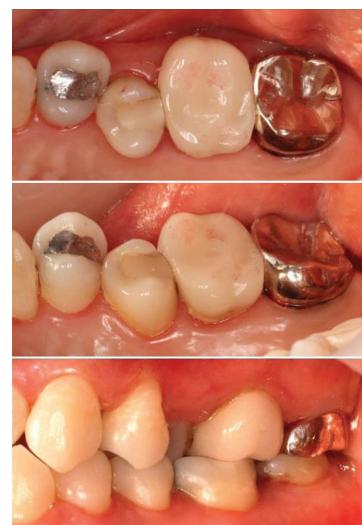
Figure 6 Immediately after the full metal crown cementation.

The crown was cemented to the tooth via the self-etching bonding system and dual-cured resin cement (Panavia F2.0, Kuraray Co., Osaka, Japan). The inner surface of the restoration was treated with 50-micron aluminum oxide air-abrasion (KCP alpha alumina 50, American Dental Technologies, TX, USA) at a distance of 10 mm for 10s with approximately 3-bar pressure [7] for supplementary micromechanical retention, followed by alloy primer application (Kuraray Noritake Dental Inc., Okayama, Japan) to achieve chemical bonding to the resin cement. The crown loaded with resin cement was then seated to the prepared tooth. After 5-second of light activation with a light intensity of 1,200 mW/cm² (Bluephase G2, Ivoclar vivadent Inc., NY, USA) on buccal and lingual aspects, excessive cement was removed using hand instruments. Glycerin gel strip (OXYGUARD II, Kuraray Co., Ltd., Tokyo, Japan) was used around the margin of the restoration and each surface was further light-cured for 40 seconds for further polymerization. After 3-minute of its initial setting time, the excessive cement was thoroughly cleaned.

The occlusion was re-evaluated to ensure the proper occlusal contact, then, all the restoration surfaces were polished and finished to attain the smooth and shiny appearance (Figure 6). The radiographic examination was conducted to ensure the cement removal (Figure 7). The final result was shown in a clinical follow-up at 3 and 9 months (Figure 8, 9). The patient was satisfied with the restoration as no sensitivity or pain had occurred during the function. In addition,

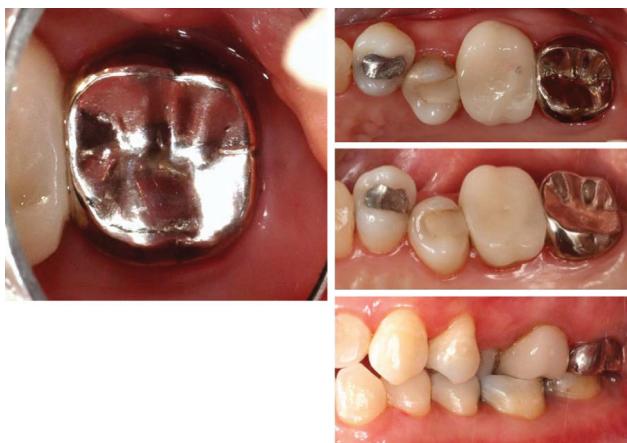
Figure 8 The final result of the restored upper left second molar with the full metal crown restoration at 3-month follow-up.

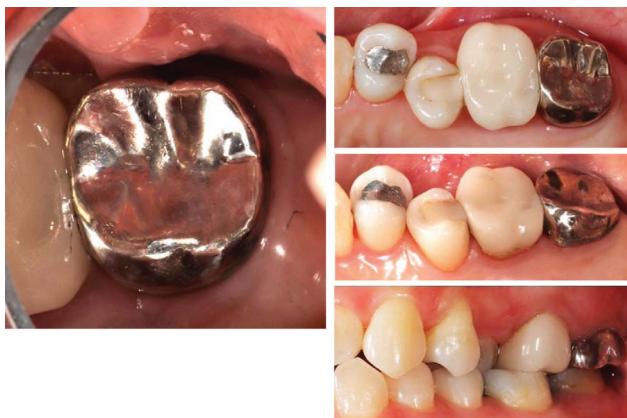
Figure 9 The final result of the restored upper left second molar with the full metal crown restoration at 9-month follow-up.
