An Investigation of a Tour Bus's Side Collision with Roadside Trees on National Highway No. 41, Pa We Subdistrict, Chaiya District, Surat Thani Province, Thailand, 3–4 Jan 2025

Abstract

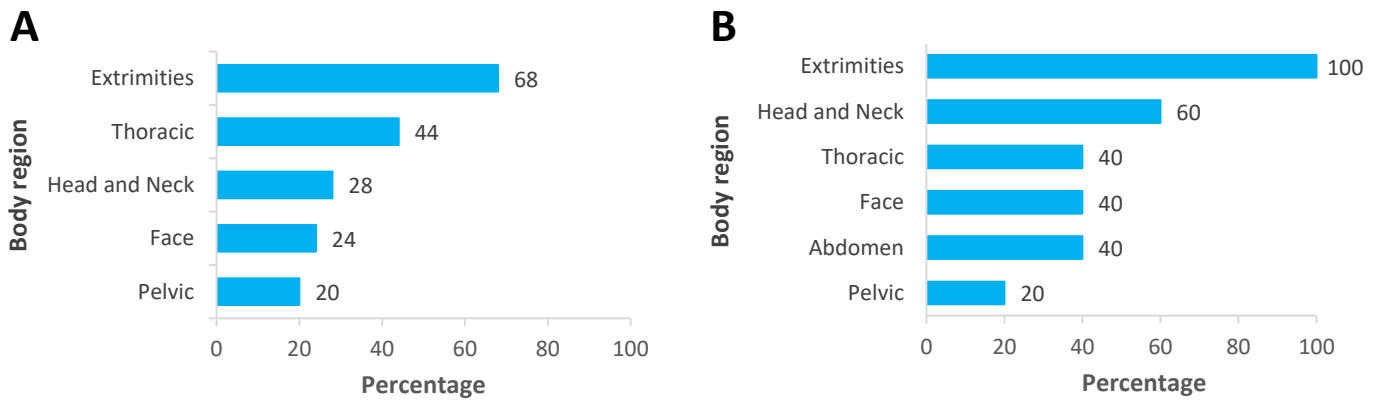
Among the injured individuals or fatalities, multiple organ injuries were observed. The affected organs were classified through the injury severity score (ISS).⁷ Out of the 25 individuals who were injured and hospitalized, 17 (68.0%) had extremity injuries, followed by 11 (44.0%) with injuries to the thoracic region and 7 (28.0%) with injuries to the head and neck (Figure 3A). Of the five who died at the scene, all had injuries on their extremities, and three had injuries to the head and neck (Figure 3B).

Figure 3. Characteristics of the body regions injured from an accident on National Highway No. 41, Surat Thani Province, 1 Jan 2025, distinguishing those injured, n=25 (A) and died, n=5 (B)
