Topography alteration of different implant surfaces after an installation

Objective: The aims of present study were to investigate dental implant surface alterations after the installation.

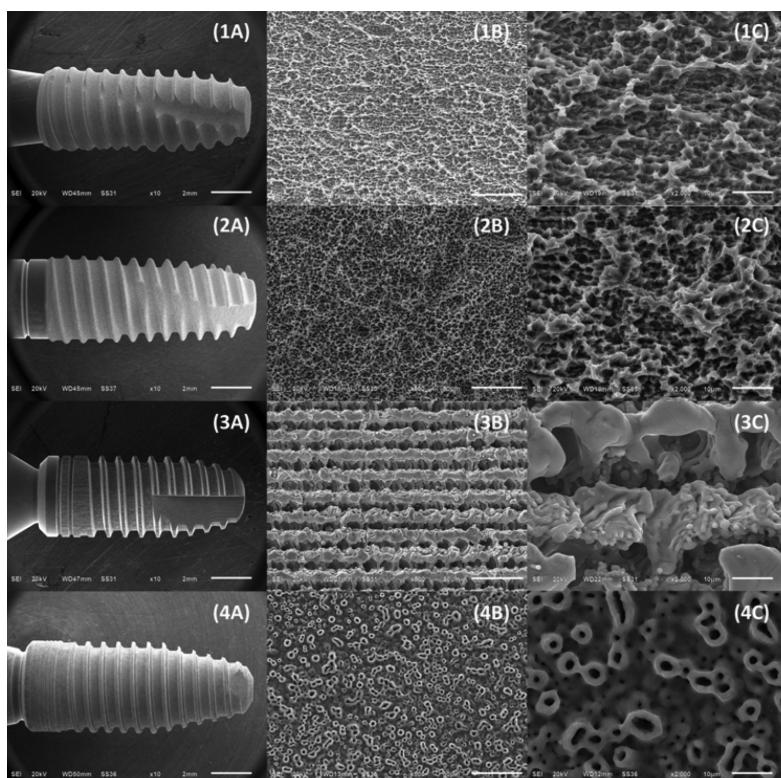
**Figure 1** SEM images of all implants

SU presented triangle-shaped thread. SEM image demonstrated a spike-like structure and porosity which presented smaller pores within larger pores. The smallest pore could be identified in submicron level. Surface morphology seemed isotropic and homogeneous over the total surface (Figure 1).

TS was similar to SU which presented the triangular threads, spike-like structure and porosity. However, surface morphology of TS consisted of deeper and larger crater from blasting process. Moreover, nano hydroxyapatite coating was visually removed after cleaning protocol (Figure 1).

BP surface showed trapezoid-shaped thread. SEM image revealed 2 levels of roughness; first, a homogeneous groovy pattern continued from coronal to apical part along the long axis of the implant, considered as anisotropic surface texture. Each groovy unit consisted top (10-15 μ m-width), cliff, and valley (10-15 μ m-width). Second, the image revealed submicron knobby-like pattern over the surface, considered as submicron and nano roughness. In addition, titanium bridge connecting between two tops and small crack lines could be generally found (Figure 1).

NO surface showed trapezoid-shaped thread with a ladder step at apical slope. Implant surface demonstrated isotropic micron sized volcano-like structure. At high magnification, the image revealed crater (1-5 μ m size) over smooth background with submicron porosity (Figure 1).

Coloum A-C showed the macroscopic and microscopic view of the implant at 10x, 500x and 2,000x magnificaiton, respectively. Row 1-4 showed SEM images of SU, TS, BP, and NO implants, respectively.
